# RDU RUNWAY 5L/23 R PRESERVATION PROJECT

ZACHRY CONSTRUCTION  
Nate Burgei & John Romaine

2023 Fall Concrete Pavement Conference  
Attendance Log  
Day 2 – Airport Technology AM Session

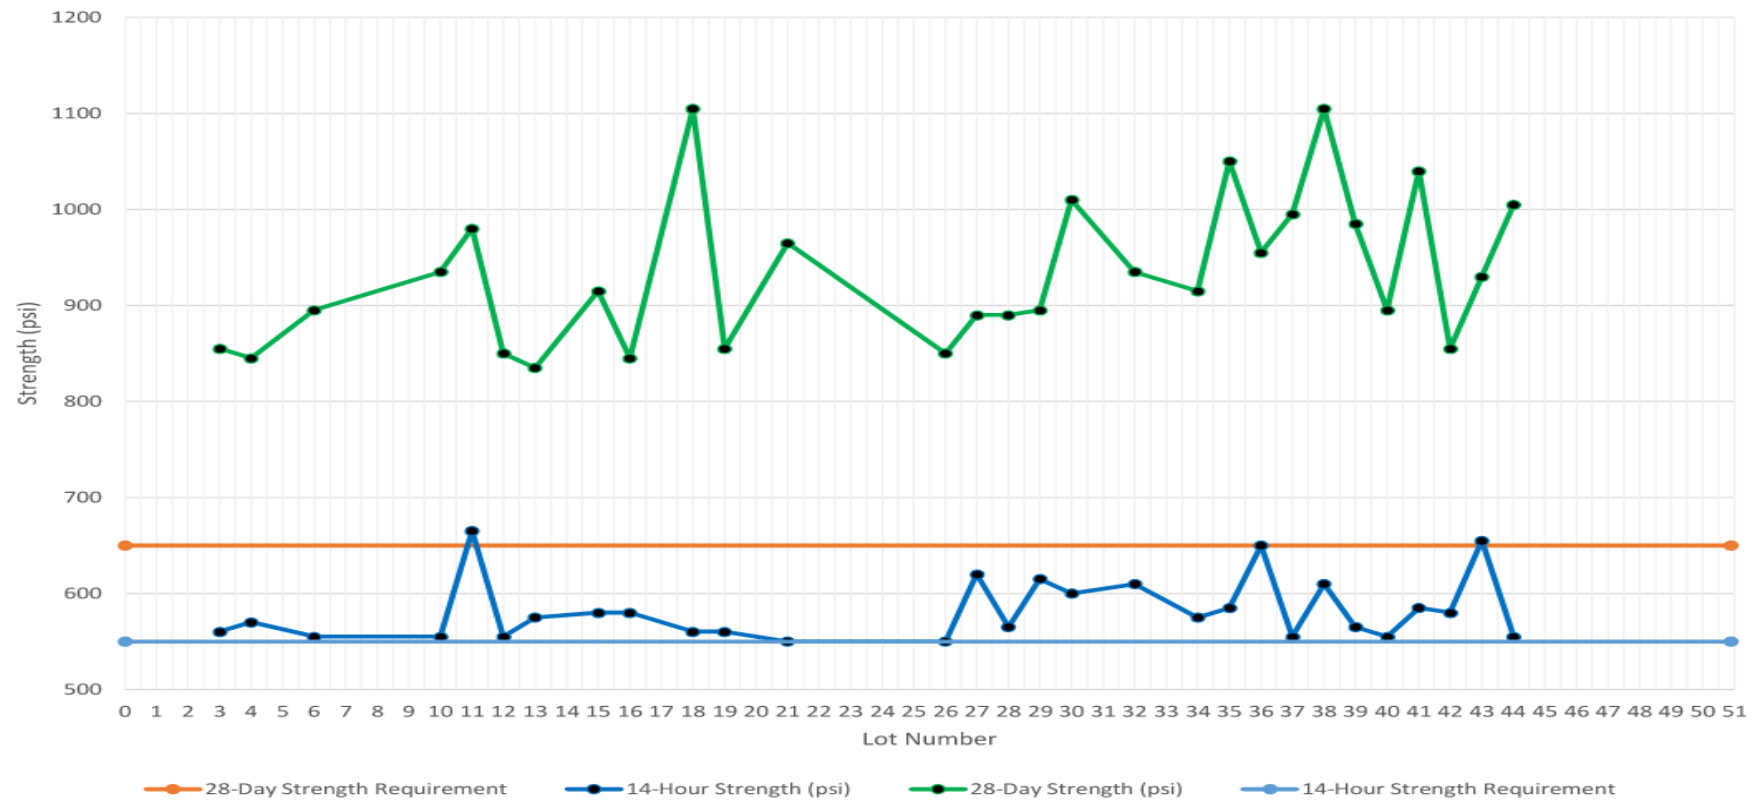
# Strength Control Chart

RDU Runway 05L-23R Preservation & TW Bravo Rehabilitation P-501 Strength Control Chart

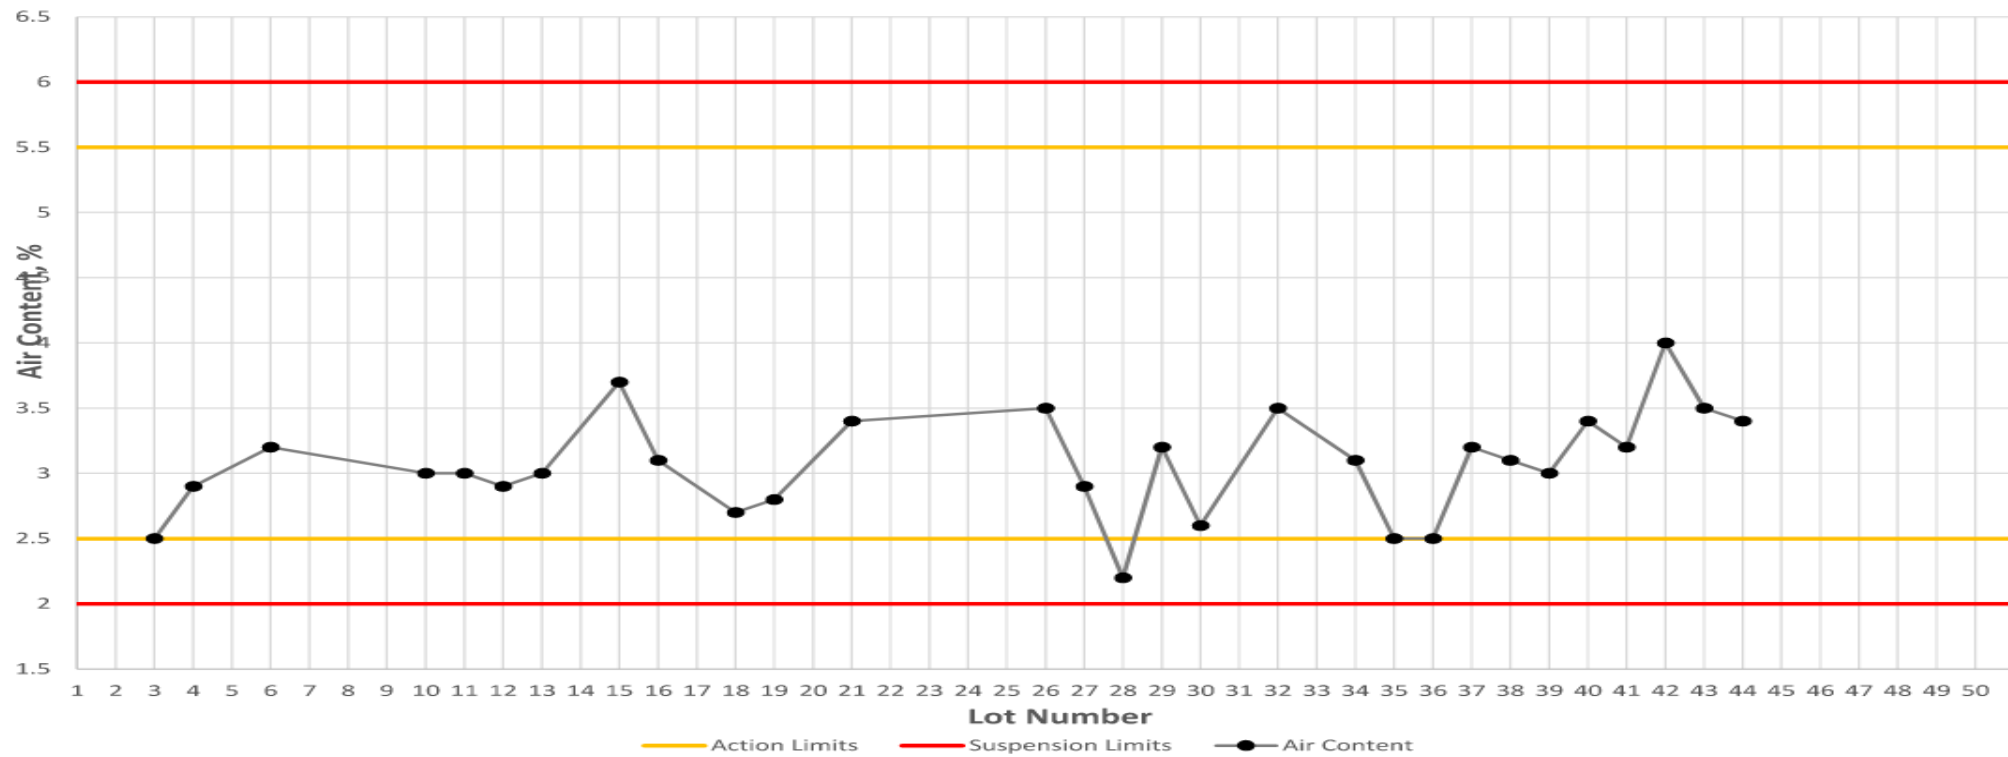
# Air Content Control Chart

RDU Runway 05L-23R Preservation & Taxiway Bravo Rehabilitation - Air Content Control Chart

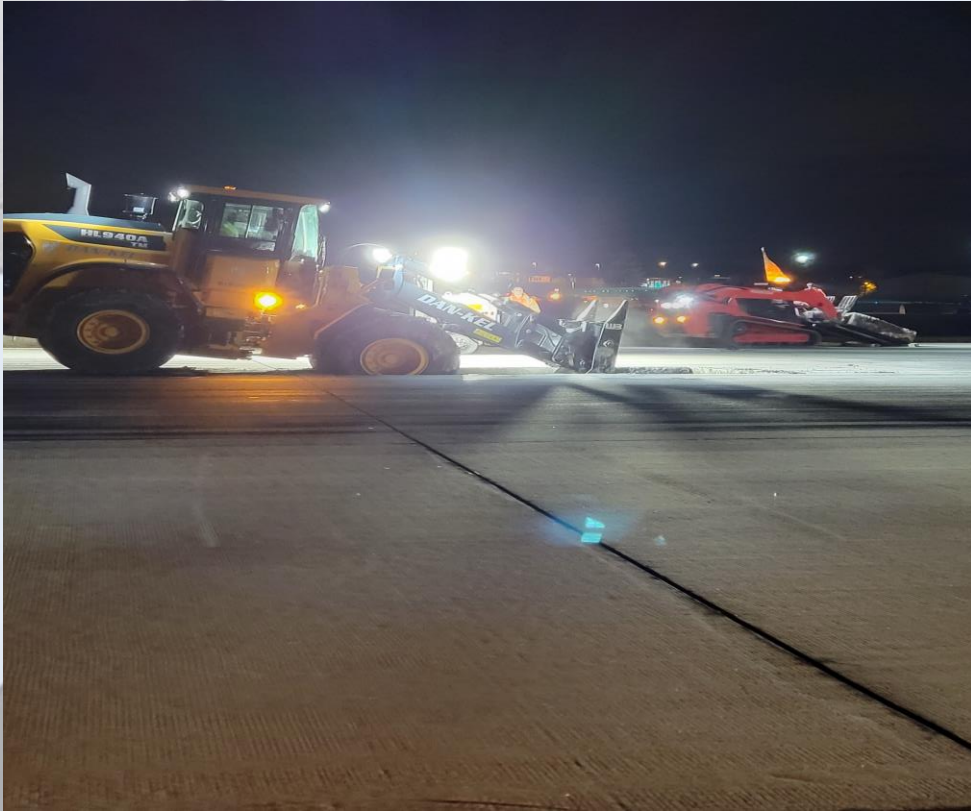
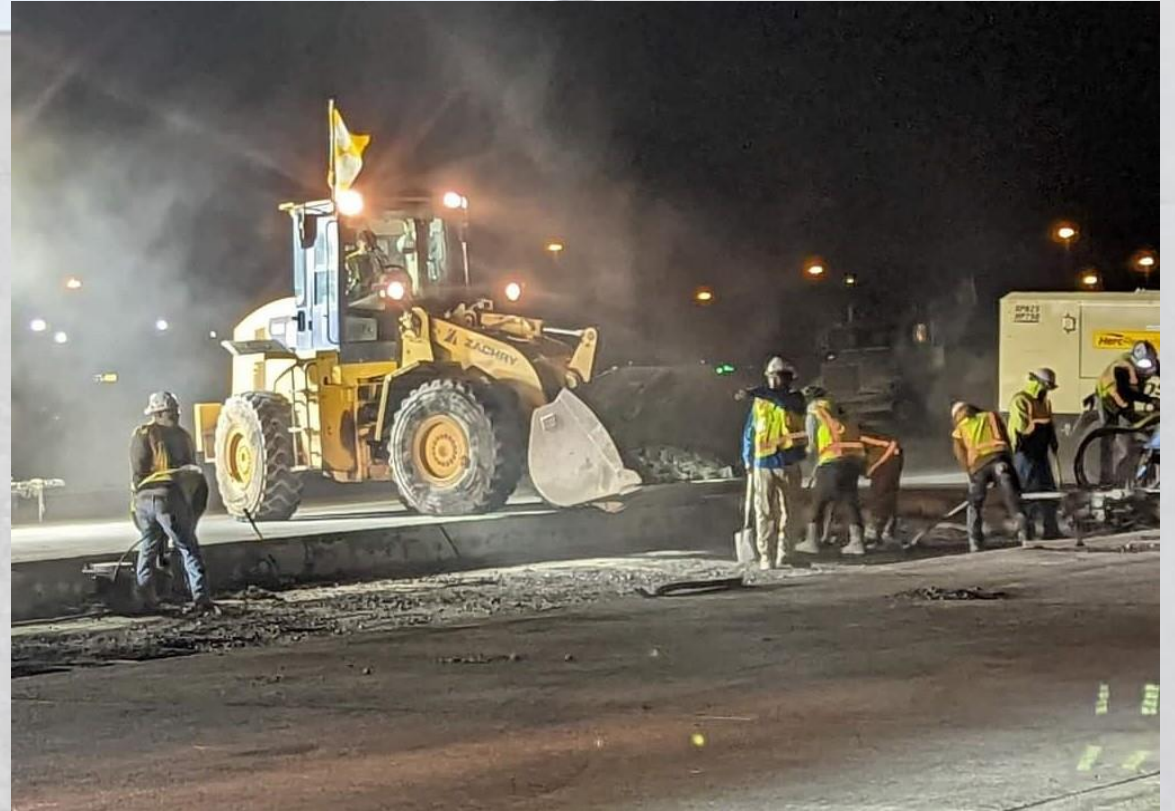
# DEMO

- Full-depth sawcut of slabs
- Pre-cut 3 slabs per night
- Cut slabs into approx. 4'x4' pieces
- Extra precaution taken around light cans
- Loaded out slabs each night and hauled to onsite crushing yard

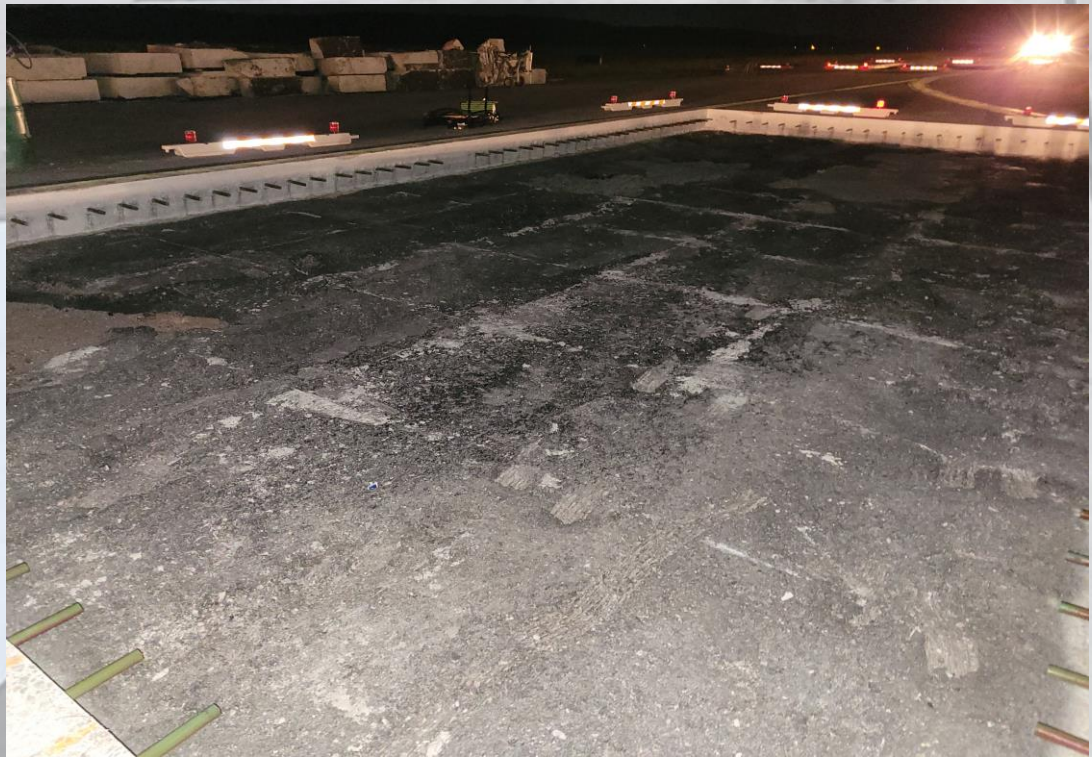
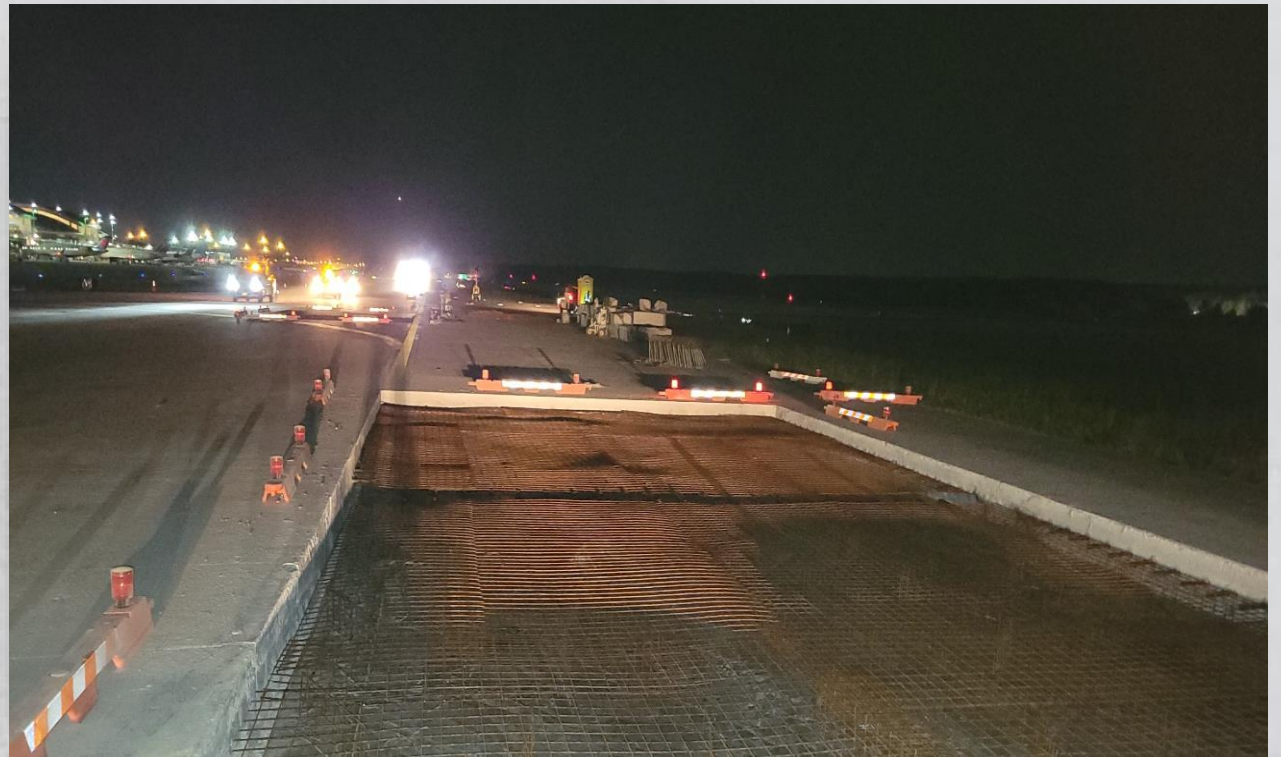
# PRE-POUR PREP

- Dowel bars required around perimeter of new slab
- Asphalt subbase repair as needed (used paving mix)
- Installation of bond breaker (10 mil poly sheeting)
- Dowel baskets as necessary
- Installation of wire mesh

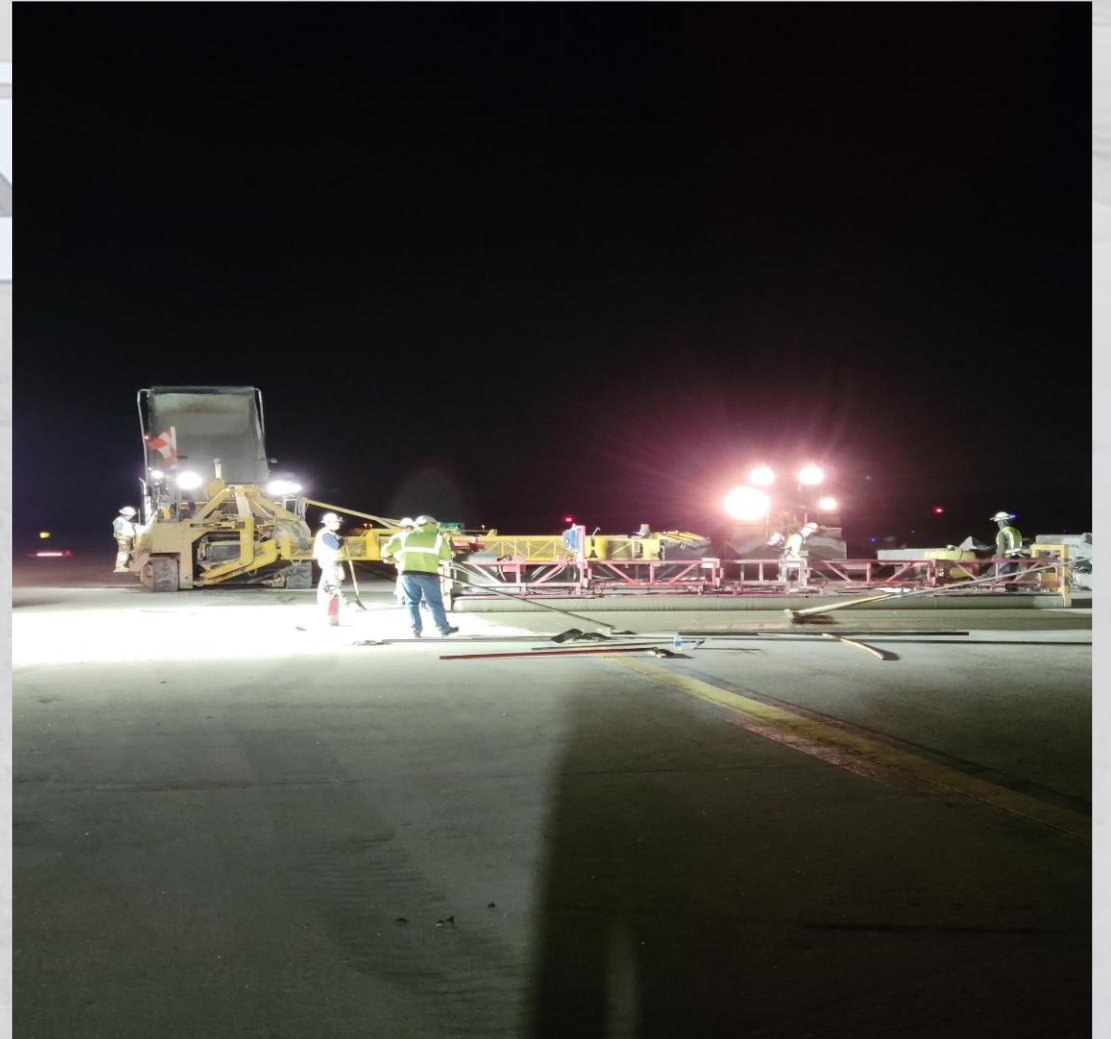
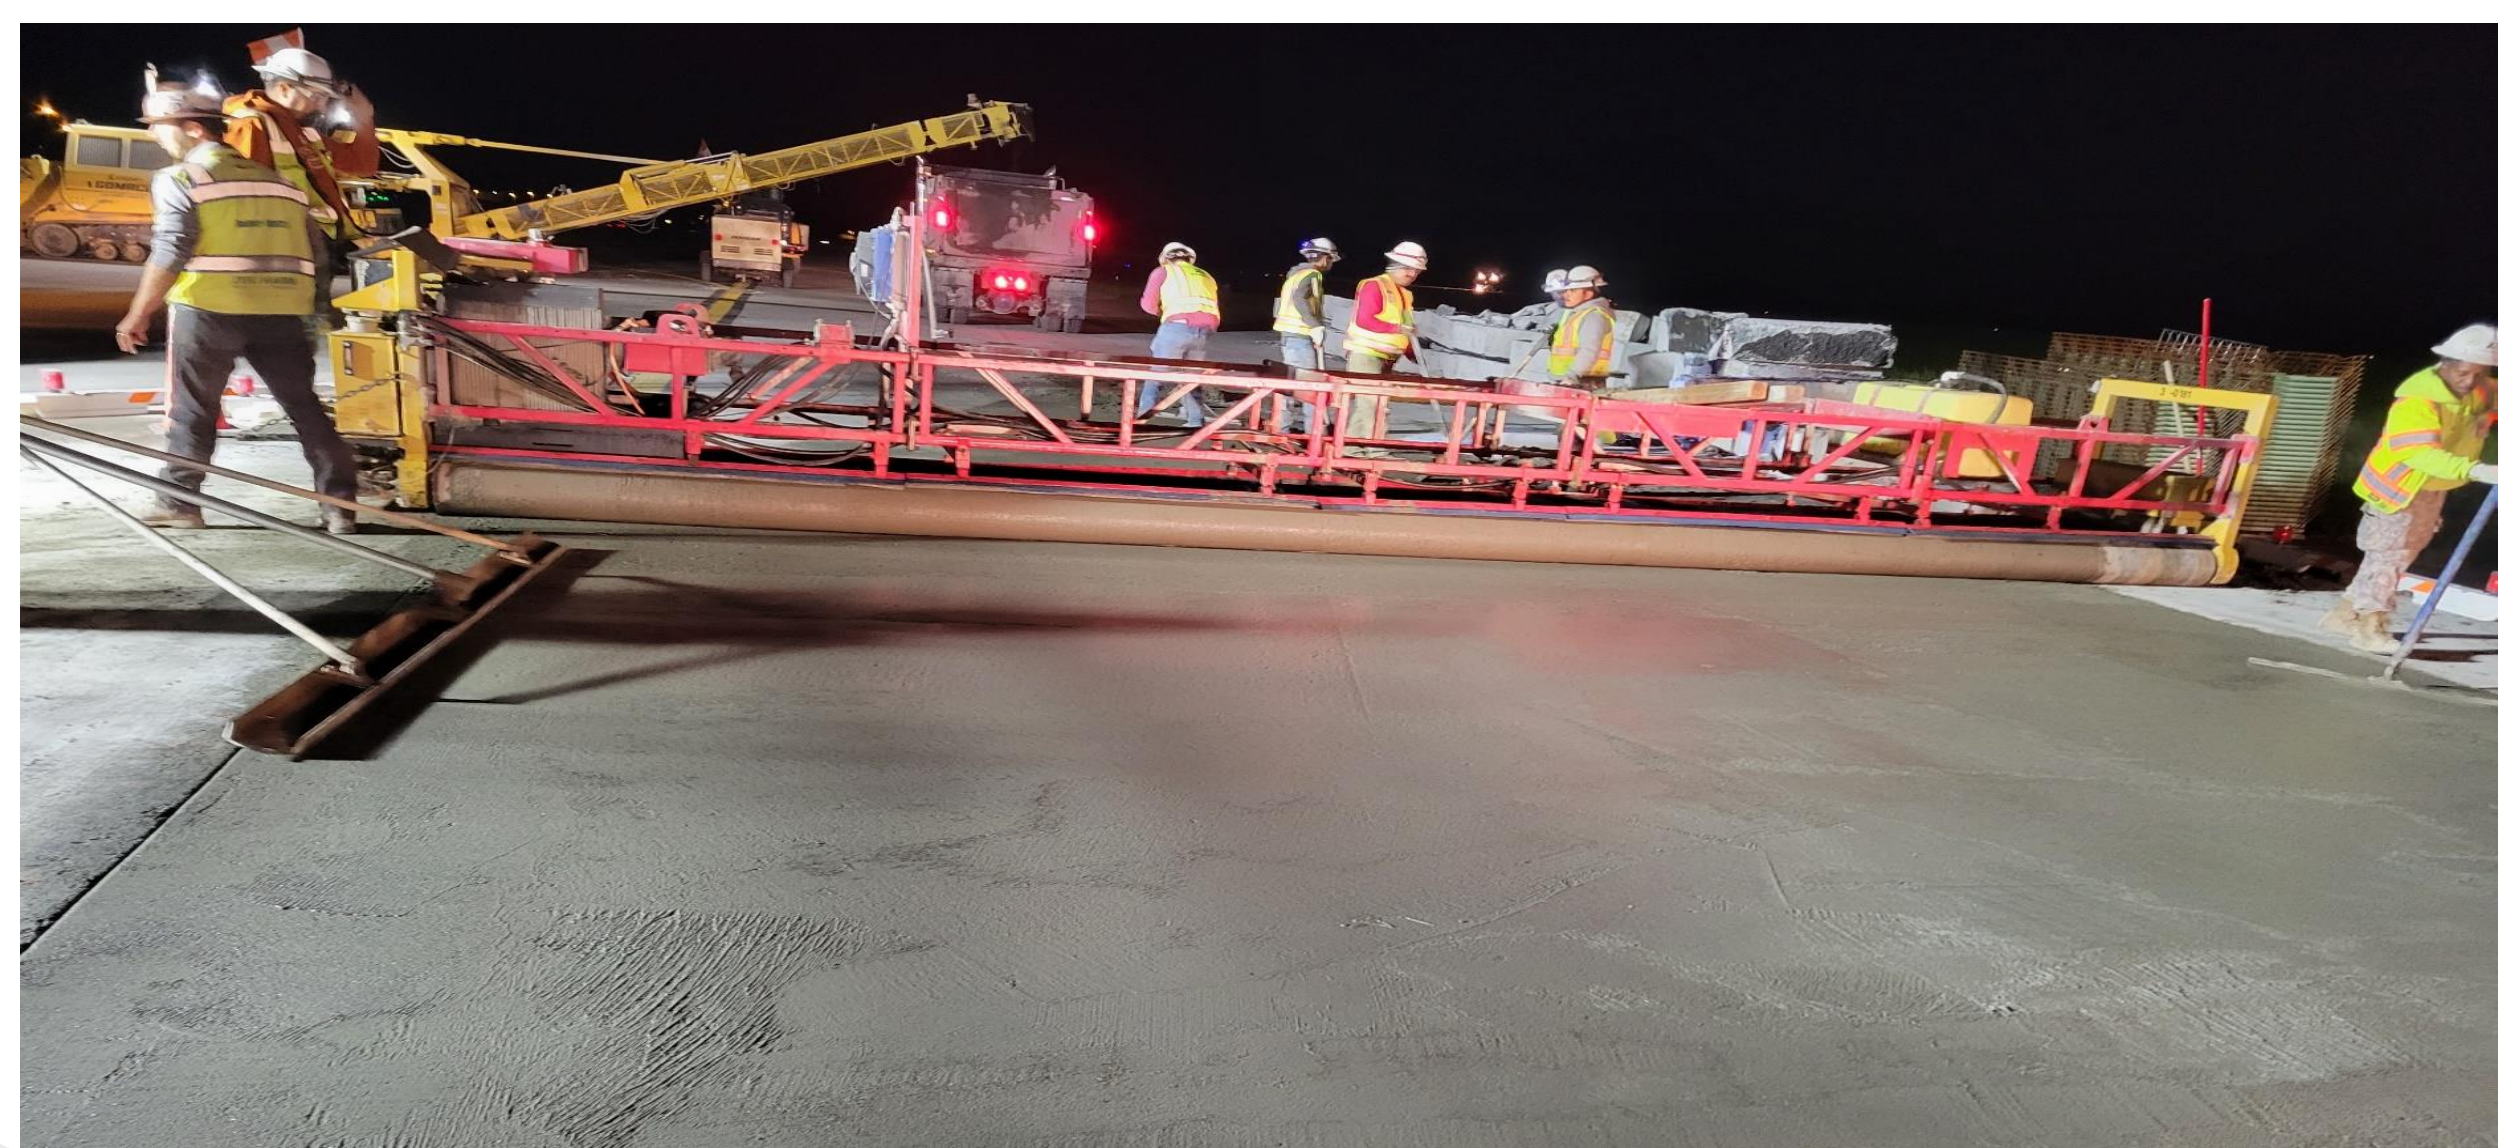
# CONCRETE PLACEMENT & FINISH

- Approx 35 cy per panel
- RTP 500 utilized for placement
- Allen 150B triple tube screed for finish
- Burlap drag required
- Hand-tined panels on the runway
- Mechanical hand-sprayer for cure

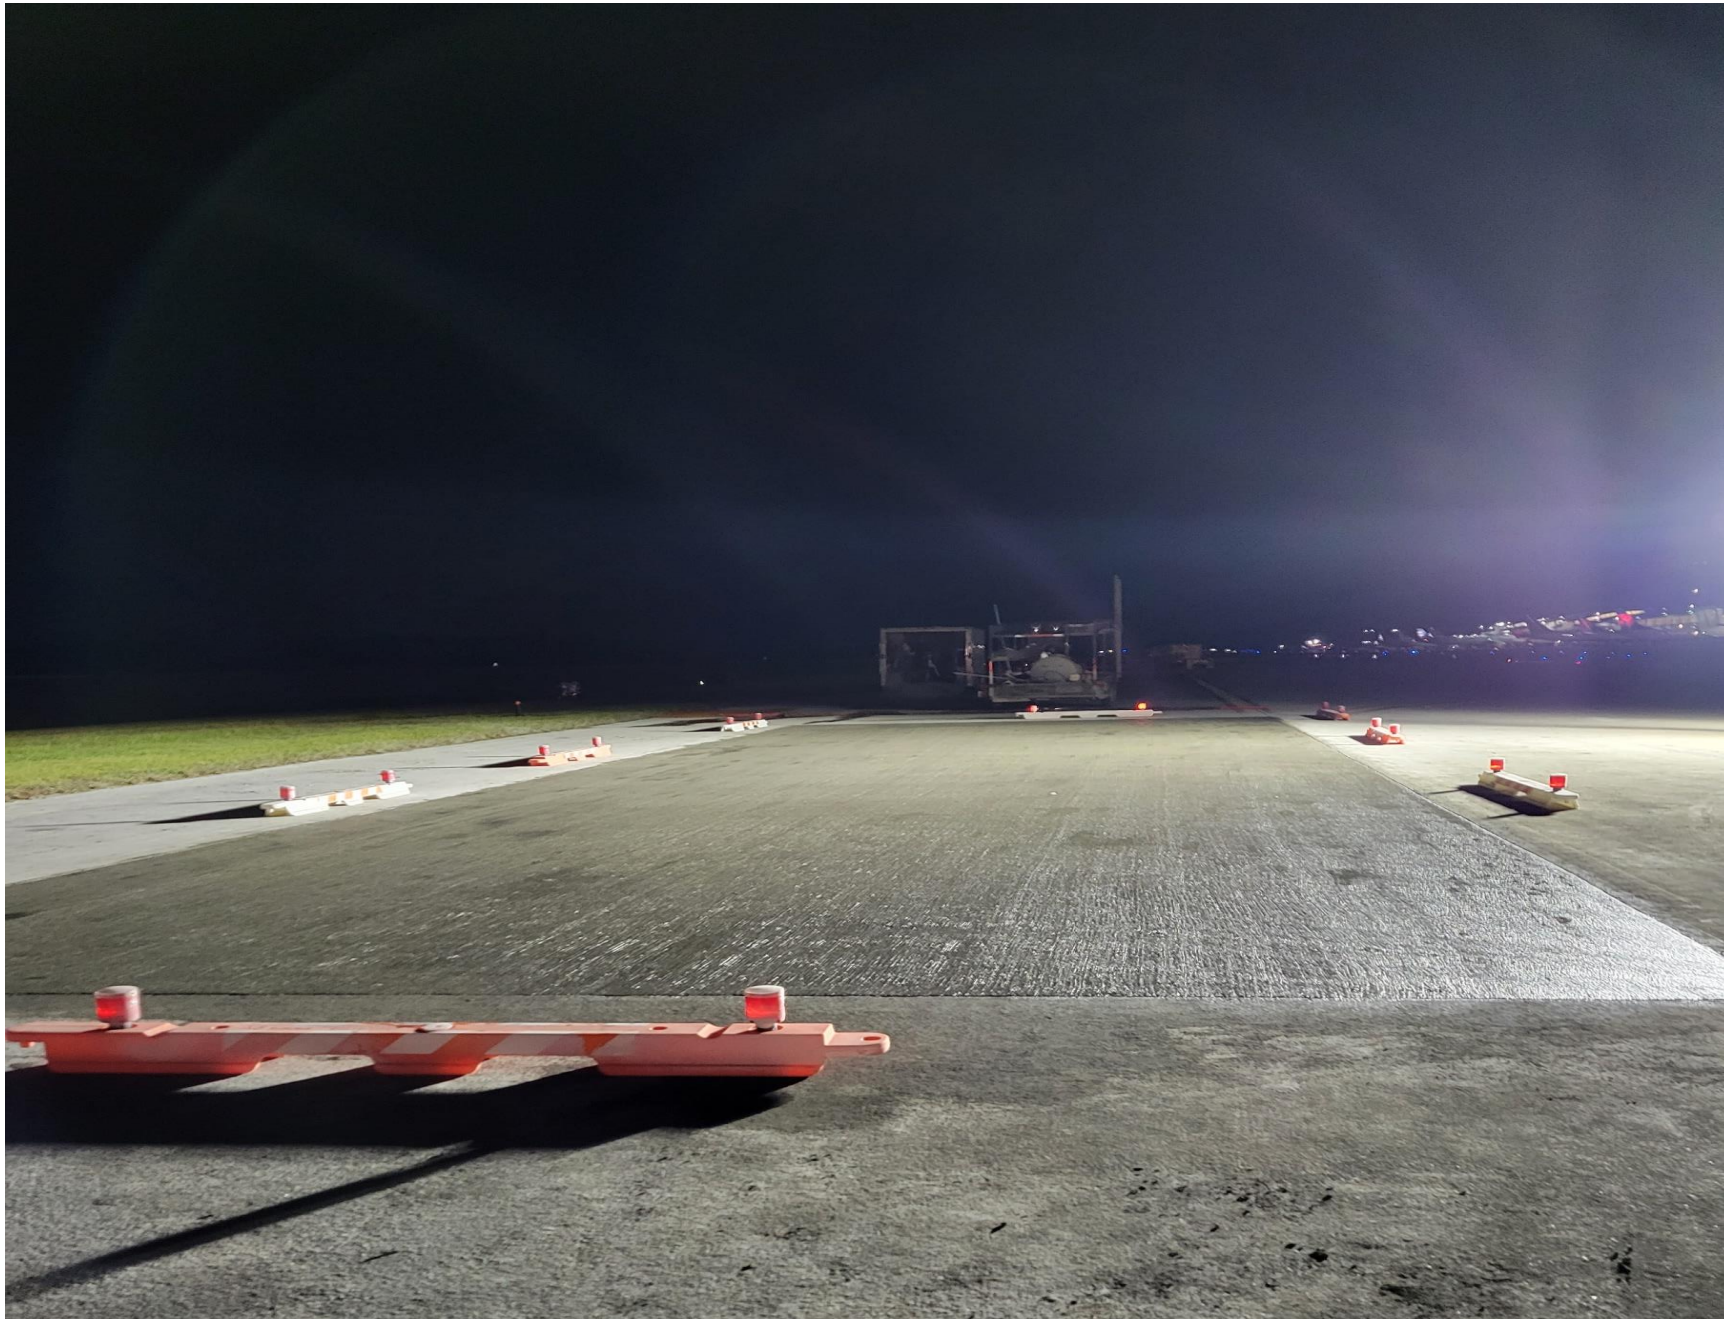
FINISING OPERATION

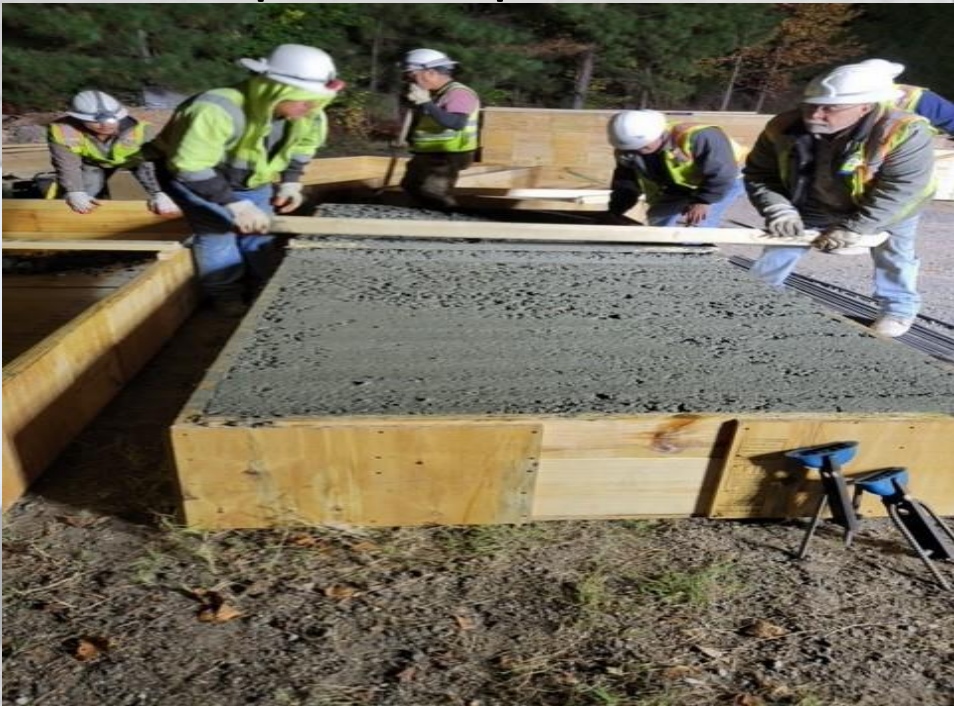
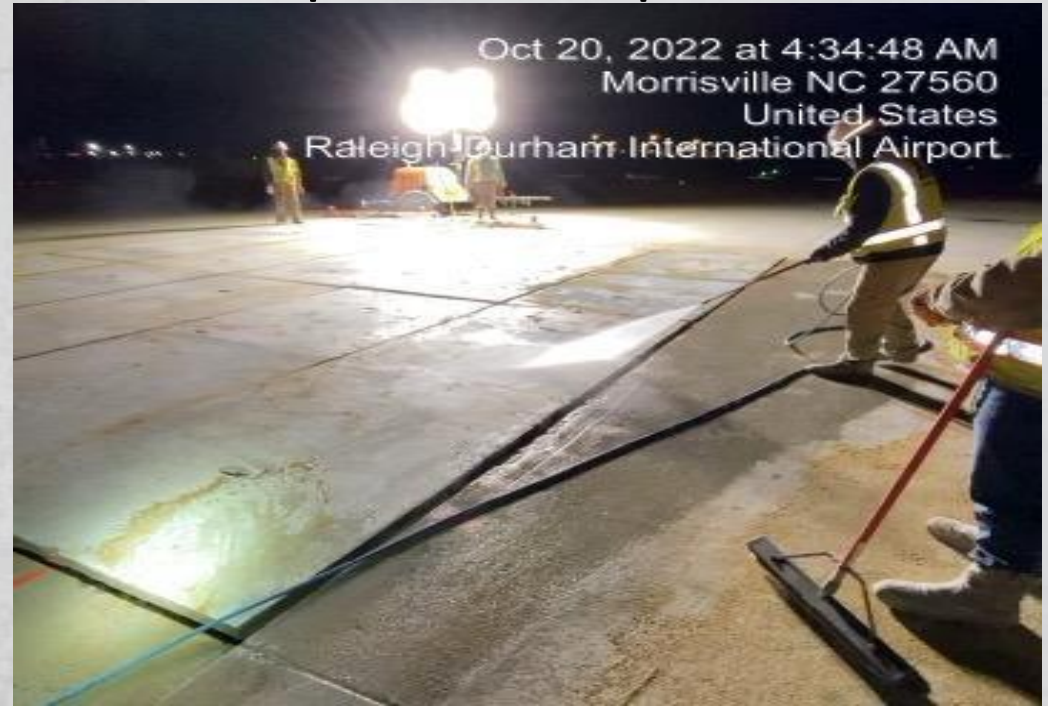
# Risk Mitigation

- Requirement per the specification to have means to open the runway if a catastrophic breakdown occurred and the panels could not be poured back in time for runway opening
- Built precast panels with lifters that could be placed in open holes
